PASSAIC RIVER BASIN  
TRIBUTARY TO PEQUANNOCK RIVER,  
PASSAIC COUNTY  
NEW JERSEY

# KAMPFE LAKE DAM NJ 00772

## PHASE 1 INSPECTION REPORT NATIONAL DAM SAFETY PROGRAM

JULY 1981

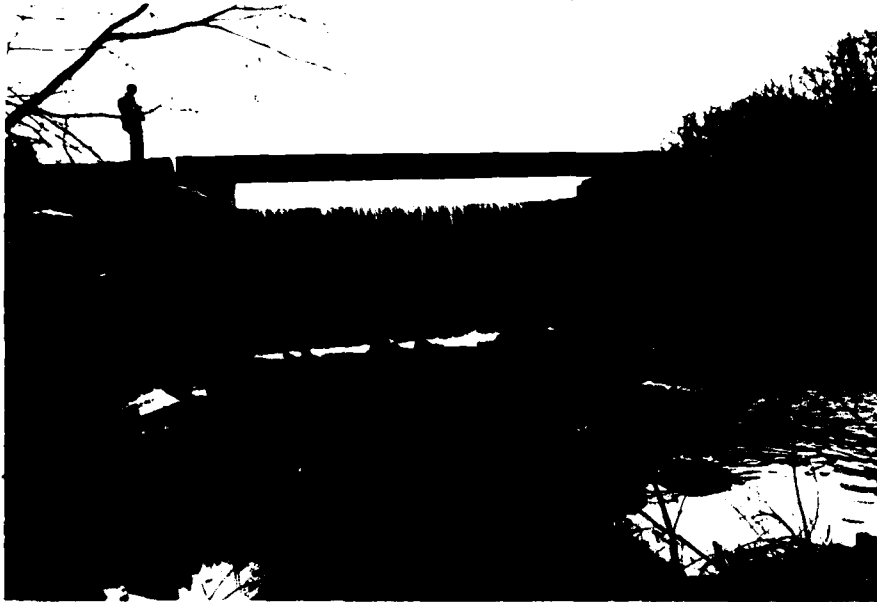
View looking u/s from below dam at overflow spillway
